# Manhole Inspection Summary

Manhole # S25CC\_042MH

Insp Date: **7/19/07 9:06 AM**

**Location** Address: **920 ARLINGTON-CARROLLTON ALLEY**

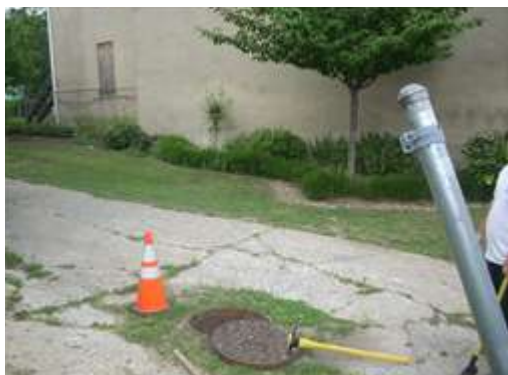
Location View

grade adjustment

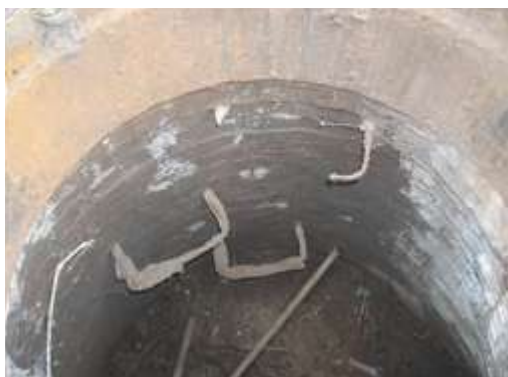
Defect 2

Count: **2** Missing: **1** ☒ **Corroded**

corroded steps and missing

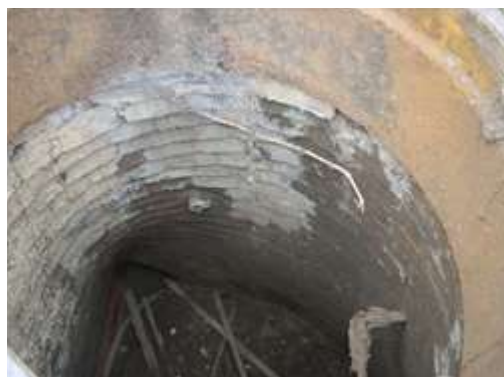
Defect 1

Infiltration: ☐ None ☒ **Joint** ☐ Cracks ☐ Mortar ☐ Roots ☐ Wall

Infiltration: ☐ None ☐ Joint ☐ Cracks ☐ Mortar ☐ Roots ☒ **Wall**

infiltration of corbel joint and barrel wall

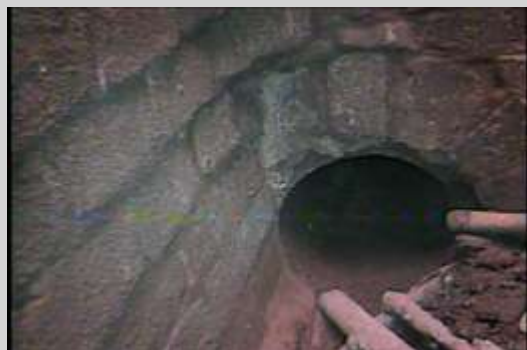
12 O'Clock Outflow

8 in. Circular Gravity Sewer  
Pipe Out @ 12 O'Clock

Infiltration: **None** Pipe Seal Cond: **Broken**
